THE WATER SUPPLY

SAN FRANCISCO, CALIFORNIA

The Earthquake of
April 18th, 1906,
and the Subsequent
Conflagration . . . .

HERMANN SCHUSSLER, Chief Engineer

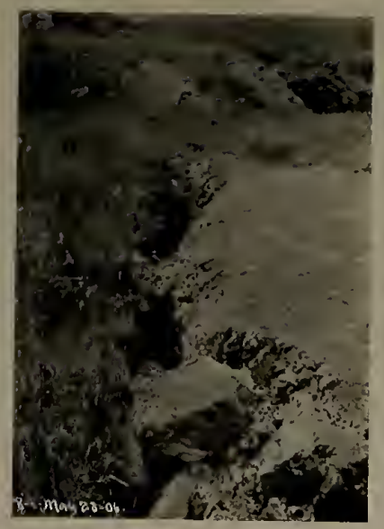
№ 29. Fault south of S.A. Dam, looking S.E. (Spillway) Crushed brick waste-weir tunnel № 33, is underground between E & F.

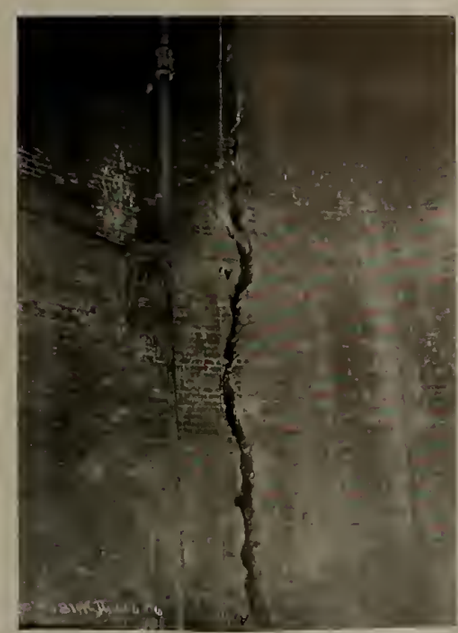
№44. View north-east. Crack A-A on picture №41, seen on inside of well = A_1-A_1

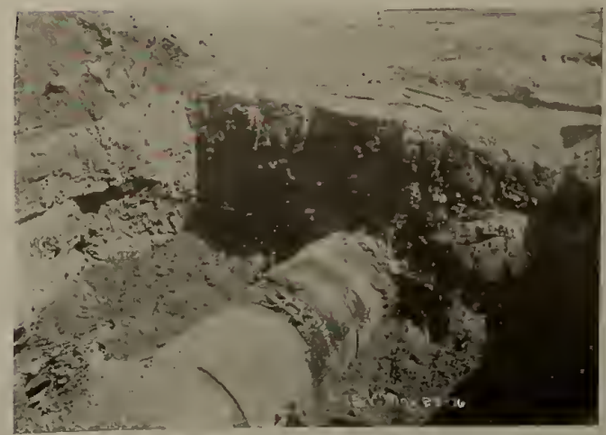
№ 60. Showing temporary emergency repair of 37" wrought iron Main Pipe on Harrison St.

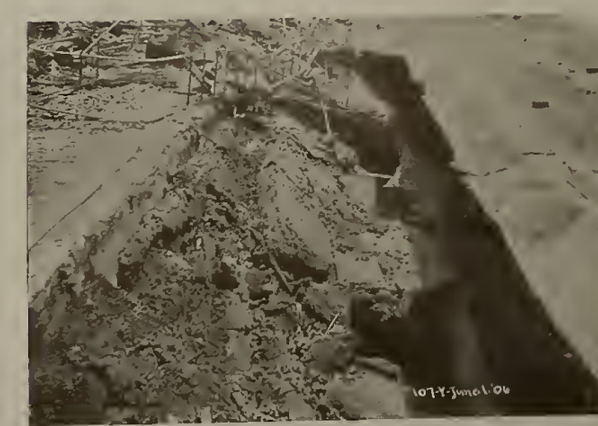
№72. 14th Str near Valencia. Sewer ruptured. 8" pipe broken same as №63, picture taken from slightly changed point.

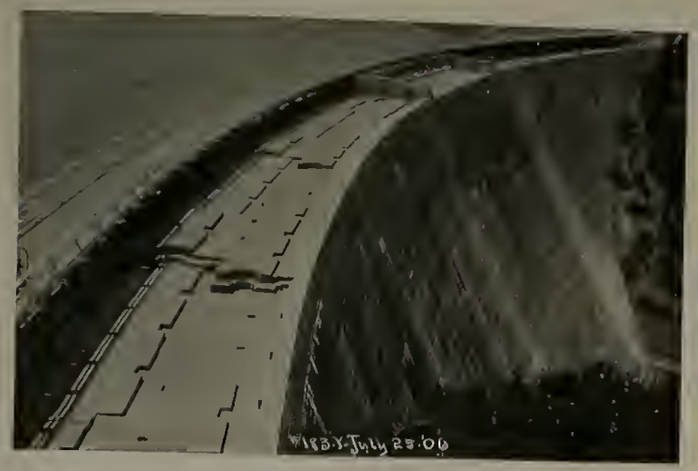
№ 98 Crystal Springs Concrete Dam. Looking N. West. Showing top, Wasteweir over Center, and lower Slope. (see № 26) & Plan 6.

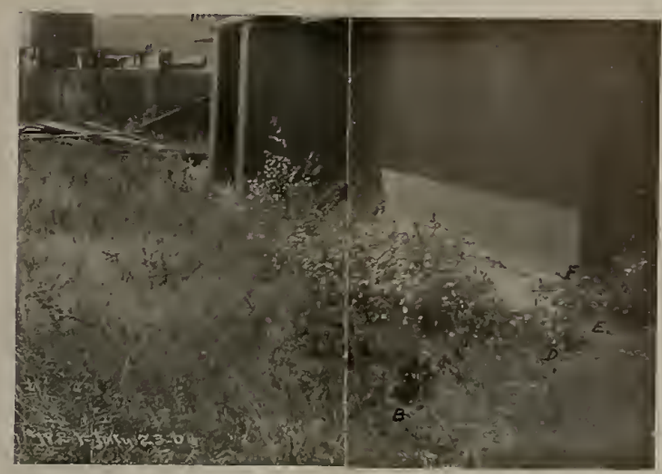
A.
№ 102. Showing San Andres brick Gatewell on the left, cracked by Fault, and Concrete Gatewell on the right uninjured. Deep Crack A-B-C-D-E struck northeast corner F of concrete Gatewell, also tore deep hole in the ground at the southeast corner. (See plan 13. & photographs from № 38 to № 45.
